APPENDIX I

Project Photo's

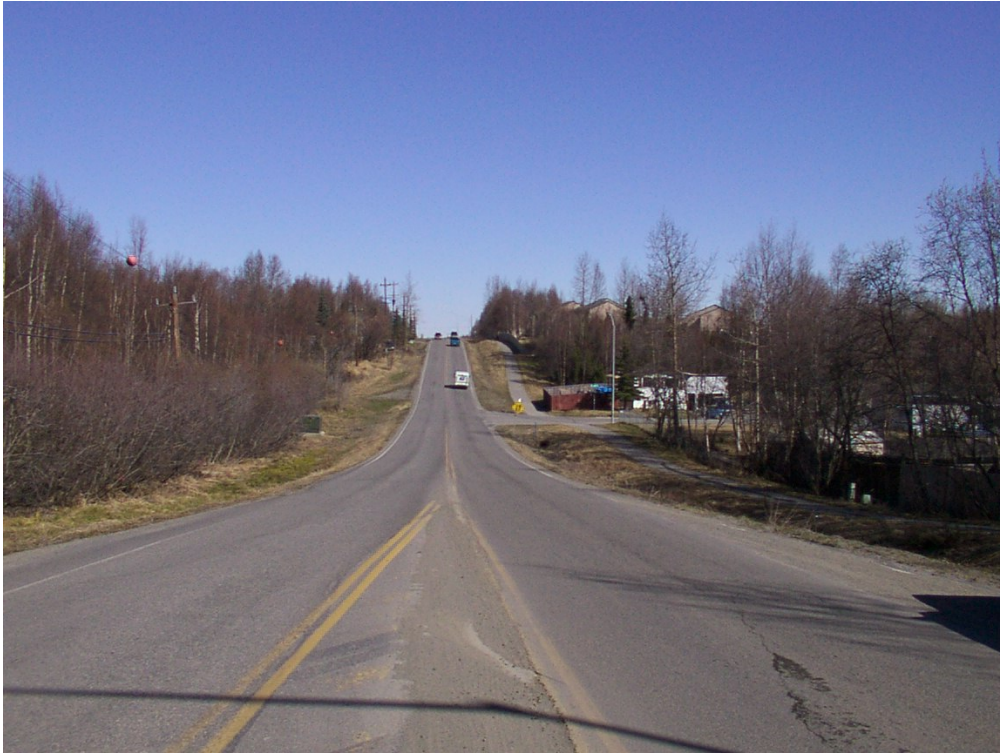
PHOTO 1

Existing Victor Road has narrow lanes and steep grades.

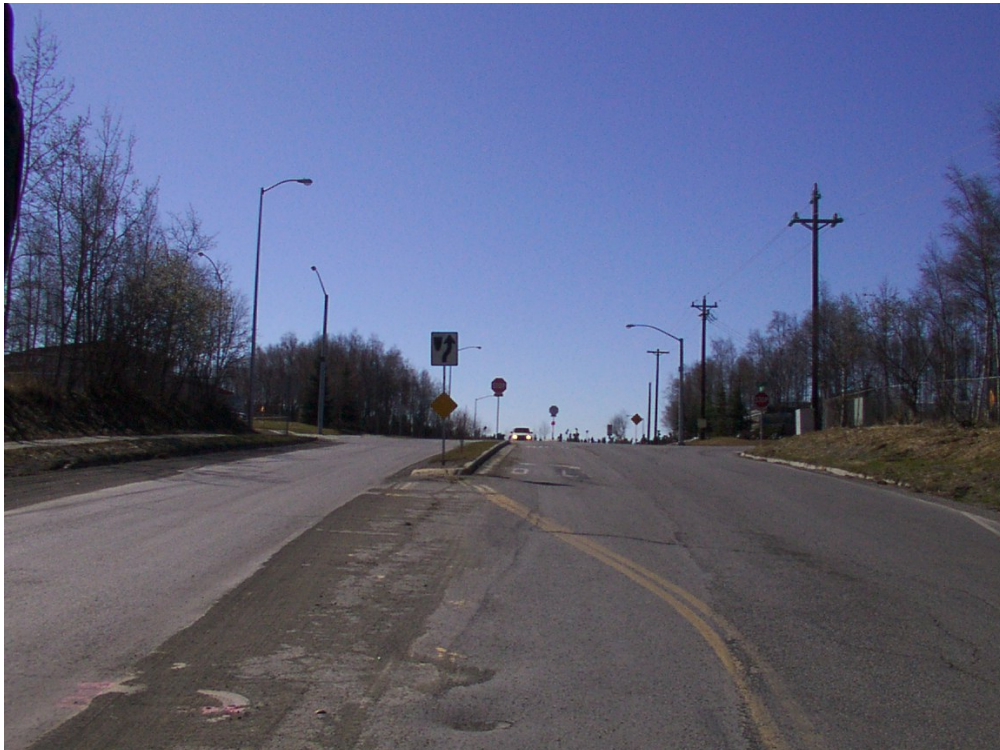
PHOTO 2

Near 100th Ave, the grades approach 8% and sight distance is poor.

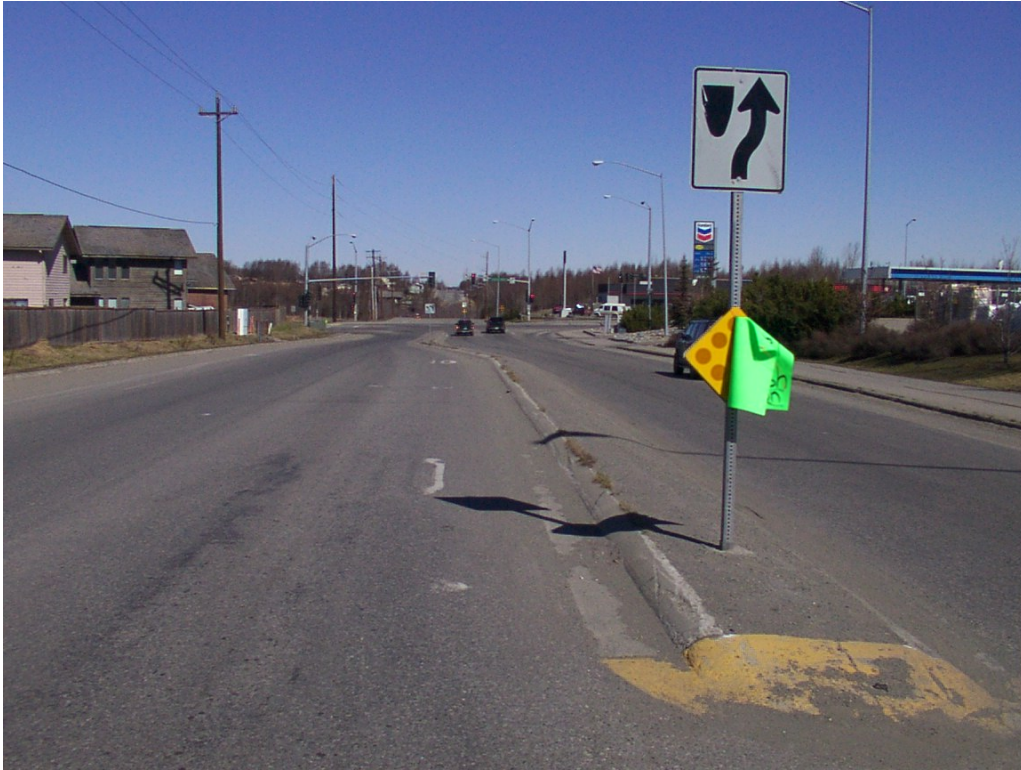
PHOTO 3

Near Dimond Blvd., Existing curb & gutter, a narrow raised median and auxiliary lane.

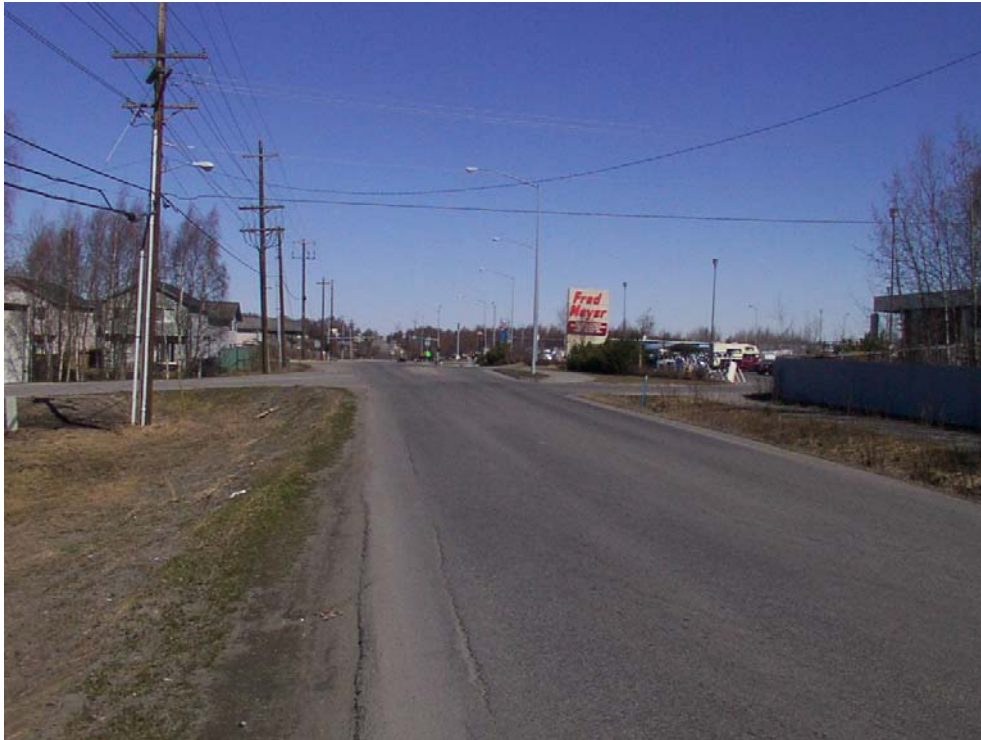
PHOTO 4

Road with narrow unpaved shoulders.

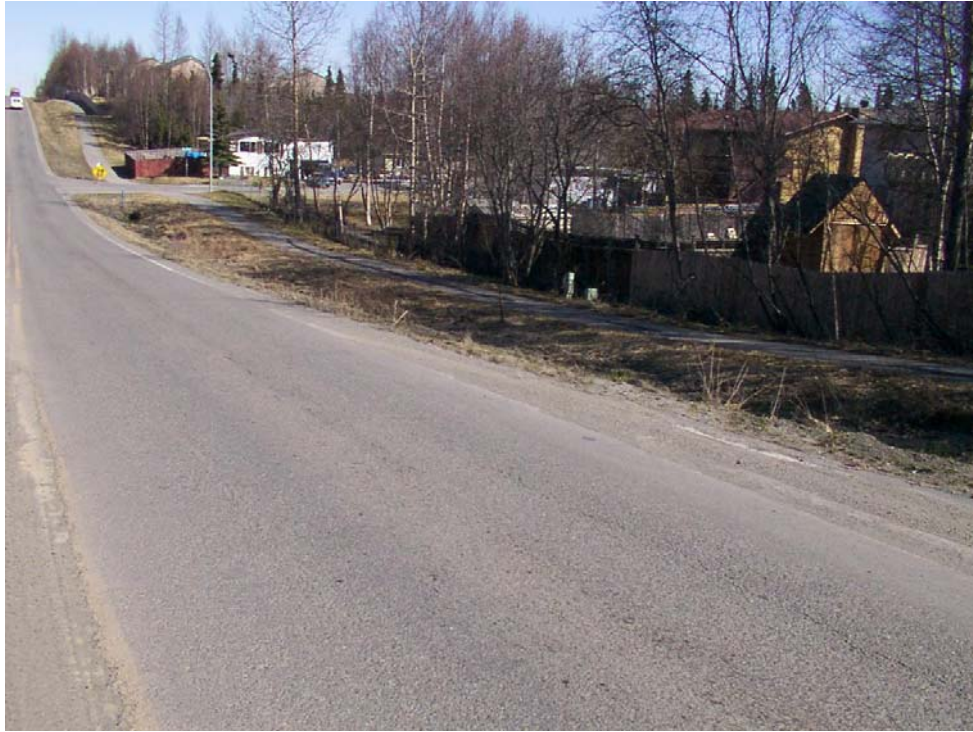
PHOTO 5

The existing road is higher than the surrounding ground and ditches are adjacent to the travel lanes.

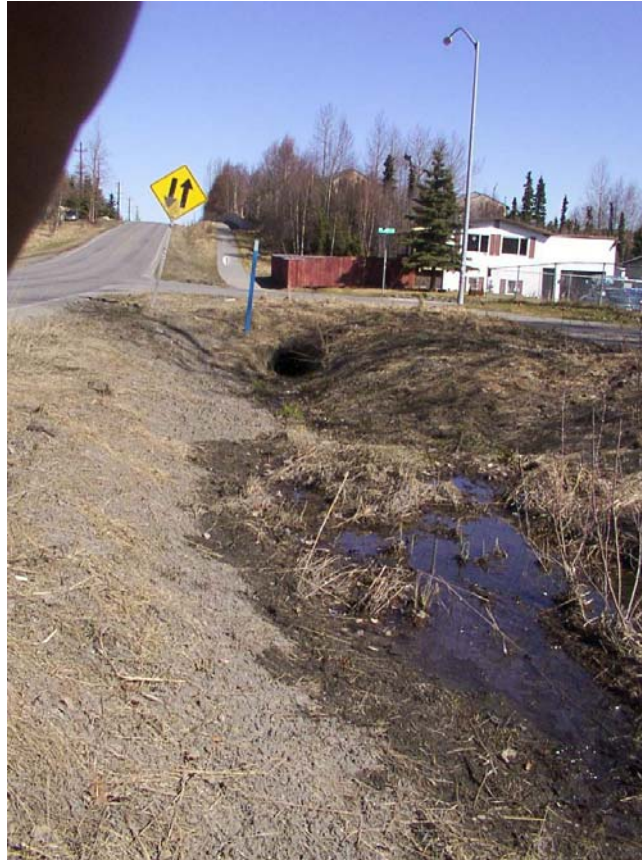
PHOTO 6

Drainage is conveyed by ditches and culvert system.

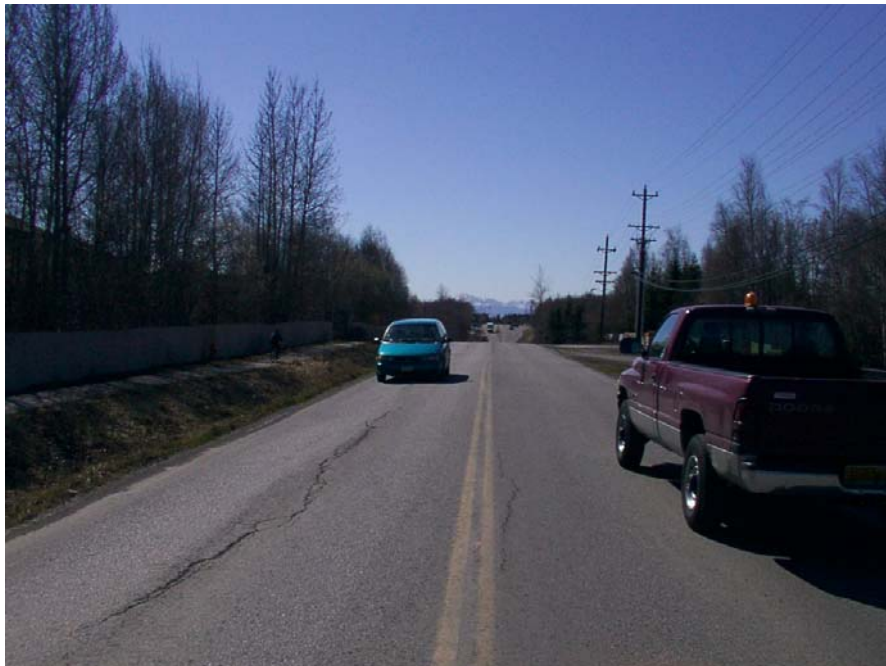
PHOTO 7

The existing pavement is in poor condition with numerous cracking.

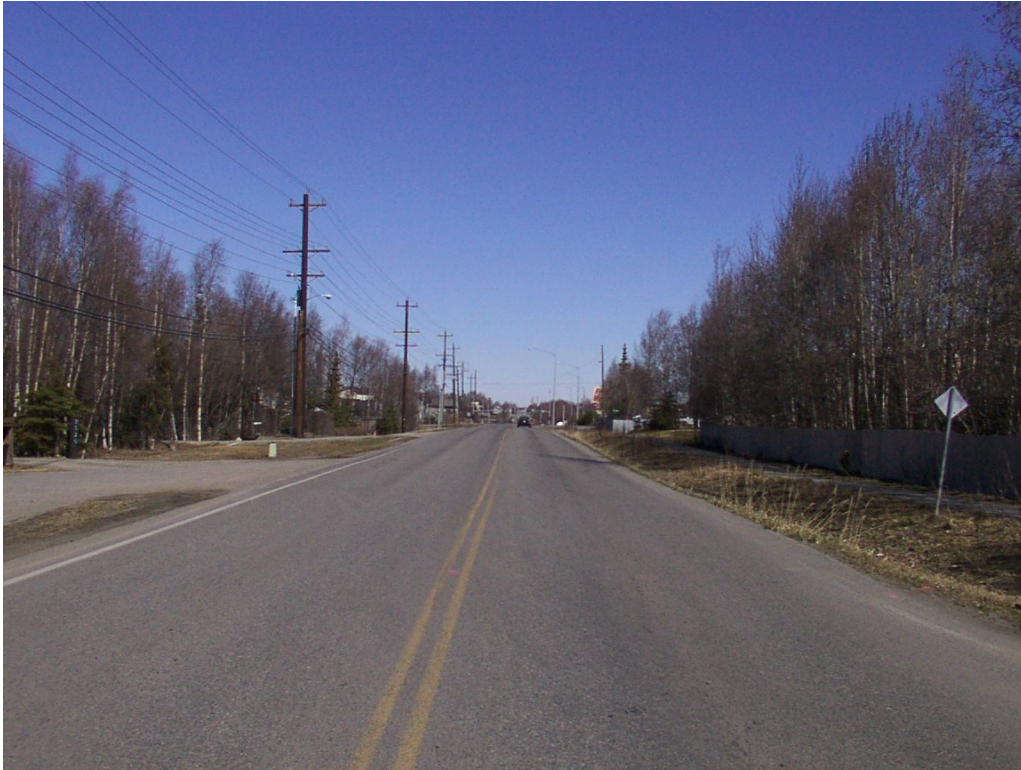
PHOTO 8

Residential driveways on the West side of Victor Road.

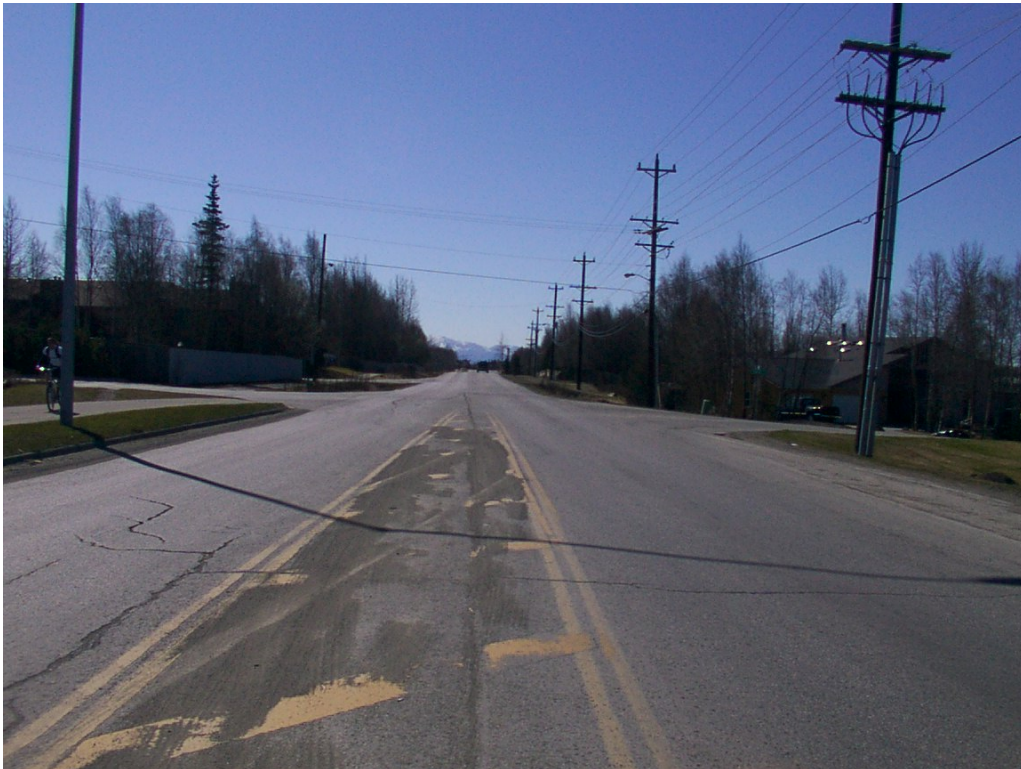
PHOTO 9

Many utilities are present in the Victor Road corridor.

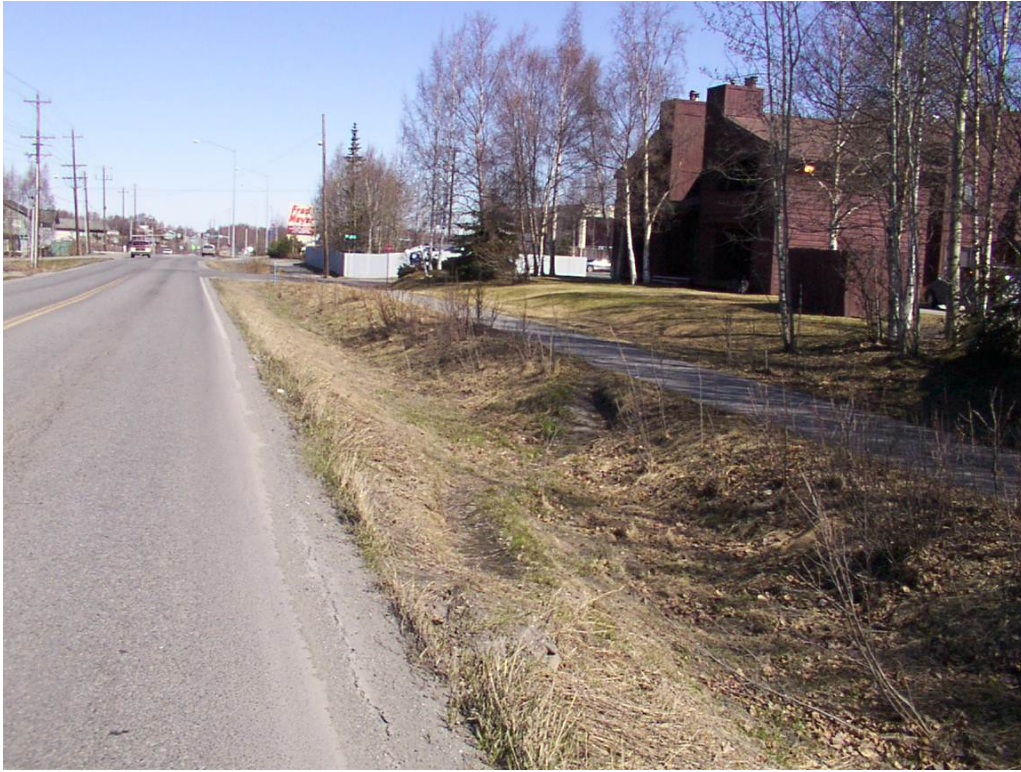
PHOTO 10

Detached pathway on East side of Victor Road.
